Hyatt Regency: the human price of failure

Sean Brady tells the stories of some of the survivors, rescuers and engineers involved in the Hyatt Regency walkway collapse.

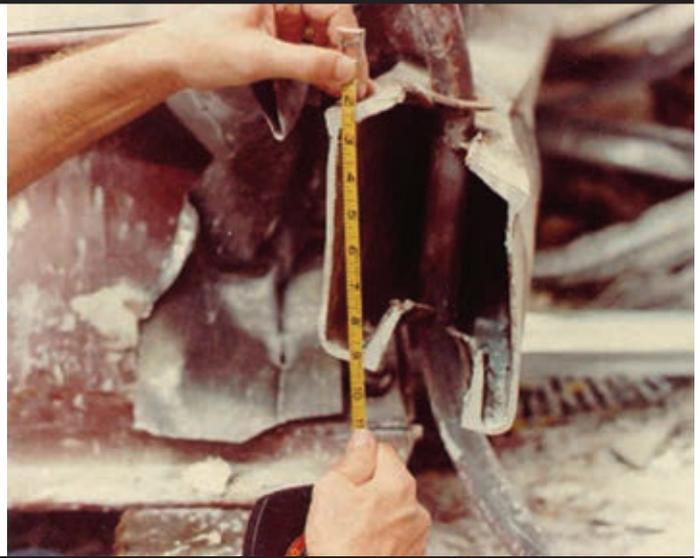
Figure 1
Deformed as-built connection

the collapse. They quickly discovered that the rods, bolts and washers that supported the fourth-floor skywalk were largely undamaged and still hanging from the lobby ceiling. Inspection of the failed walkways confirmed the cause of failure: the two channels that transferred the walkway loading into the steel rods had deformed, allowing the rods’ nuts and washers to pull through the connection (Figure 1). At about 3 am that morning they got to their hotel, and Gillum did some quick calculations, discovering that the as-built connection was “grossly inadequate”. He tried to get some sleep but was “numb with despair and grief”³.

Warning signs that could have raised the alarm were missed. The connections' channels began to deform under self-weight alone soon after installation³. While the owner's inspector noticed the deformations and reported them, the report was not followed up. A workman also noticed the deformations while installing plasterboard on the walkways, but thought nothing of it. And once the plasterboard had been installed,

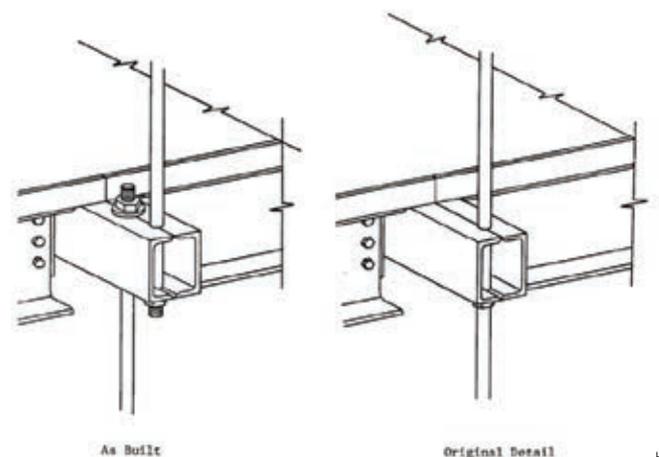
Over time Gillum’s view would be confirmed, with a paper by Moncarz and Taylor on the failure summarising that “the collapse occurred because of the doubling of the load on the connection resulting from ill-considered change of an ill-defined structural detail”⁴. So what was this change? The as-built connection consisted of two steel rods, the upper rod connecting the fourth-floor walkway to the lobby roof, and the lower rod supporting the second-floor walkway below (Figure 2). The original connection detail, however, consisted of only one rod, with a nut and washer transferring the walkway loading into the steel rod (Fig. 2)⁵.

The change resulted in a doubling of the load on the fourth-floor walkway connection, with Henry Petroski comparing the mechanics of the change to that of two men gripping

a rope hung from the ceiling⁶. The original detail is akin to two men hanging from a rope, one above the other. Neither man will fall as long as their grip is sufficient to support their own individual weight. However, the as-built connection is analogous to cutting the rope just below the upper man and tying it to his leg. The upper man is now carrying his own weight, plus the weight of the man below, with his grip being required to carry the additional load. If the upper man's grip was not up to the task, then both men would fall, which is what happened to the walkways.

Figure 2
As-built and original detail
